Preliminary Review of Coastal Conditions at Woodland Beach Tiny Township, County of Simcoe

August 10, 2008

Woodland Beach Site Visit Tiny Township, Simcoe County August 10, 2008

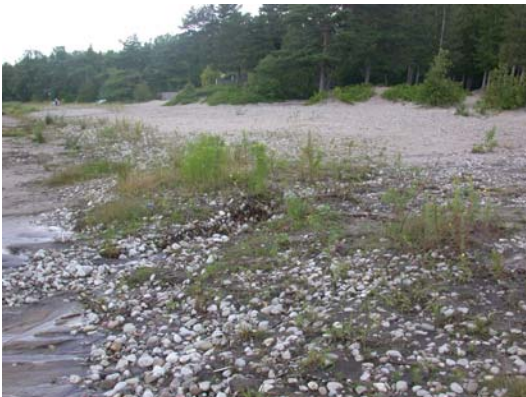
Cobble beach with sand veneer at the upper portion of the beach.

Recommendation – Educate members about the significance of cobble beaches and their role along the coast. Not only do they provide habitat for numerous plants and animals, but they provide important armouring of the shoreline that helps protect cottages during high lake levels and storms. Removal of the armouring can create erosion conditions.

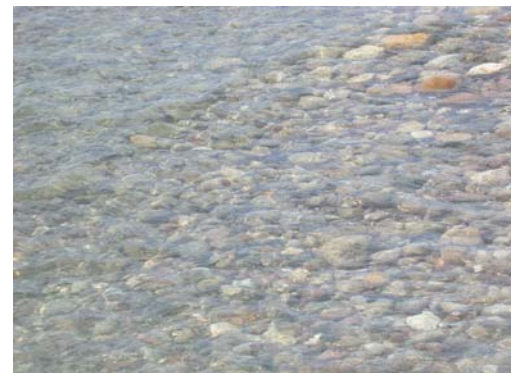
Nearshore cobbles forming a protective armouring of the shoreline.
